# Case study of implant-supported restorations after a generalized, severe chronic periodontitis

by Dr. Dr. Philipp Plugmann, MSc MSc MBA, Leverkusen/Germany

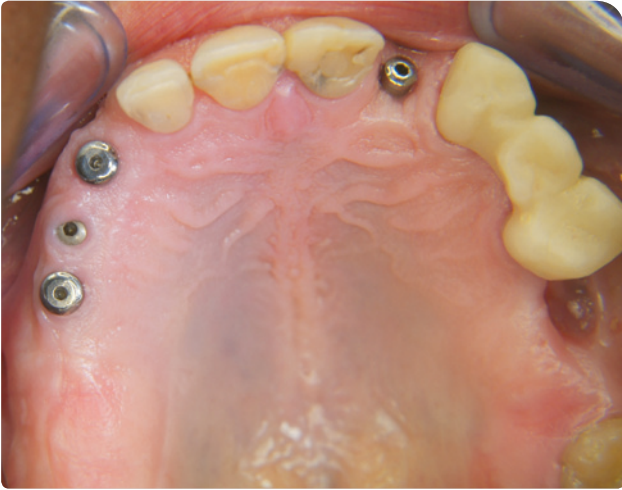
**Fig. 1:**  
Gingiva formers upper jaw: 13, 14, 15 and 22 as well as the long-term temporary restoration 23-25

After exposing the IMPLA implants in the upper and lower jaw (Fig. 1 and 2), we first prepared and molded the metal framework (Microlit isi, Schütz Dental) for the future bridge 23-25-attachment 26. Up to this date, the patient wore a long-term temporary restoration (Temdent Classic, Schütz Dental) 23-25 (Fig. 1).

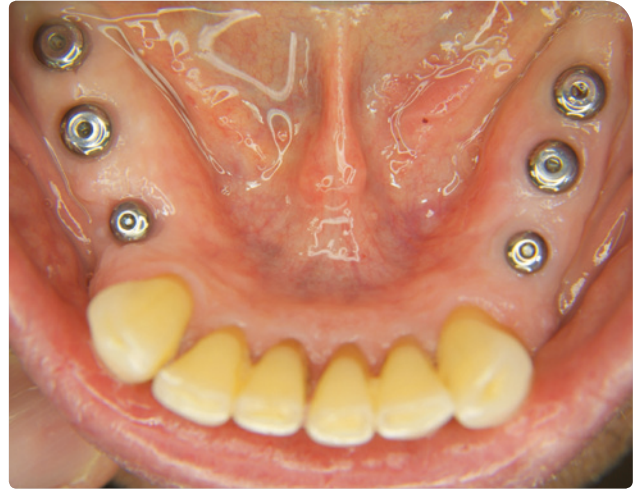
**Fig. 2:**  
Gingiva formers lower jaw: 34, 35, 36 and 44, 45, 46

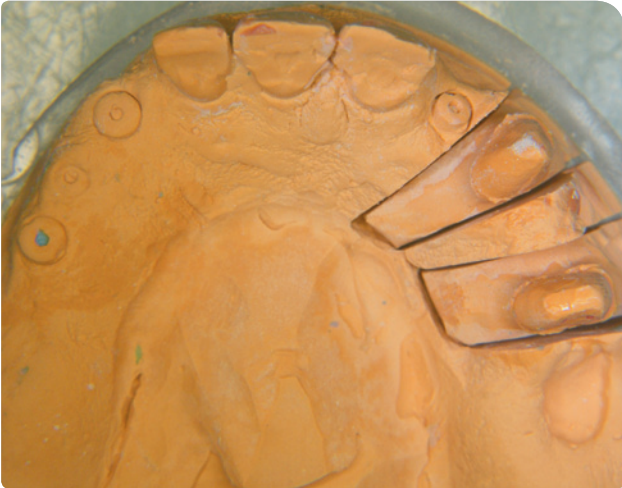
**Fig. 3:**  
Plaster die with model of the framework 23-25-attachment 26

The dental lab affiliated with our practice prepared the plaster die with the model of the framework 23-25-attachment 26 (Fig. 3) and then produced the framework (Fig. 4). Afterwards, the framework 23-25-attachment 26 was fitted intraorally (Fig. 5).

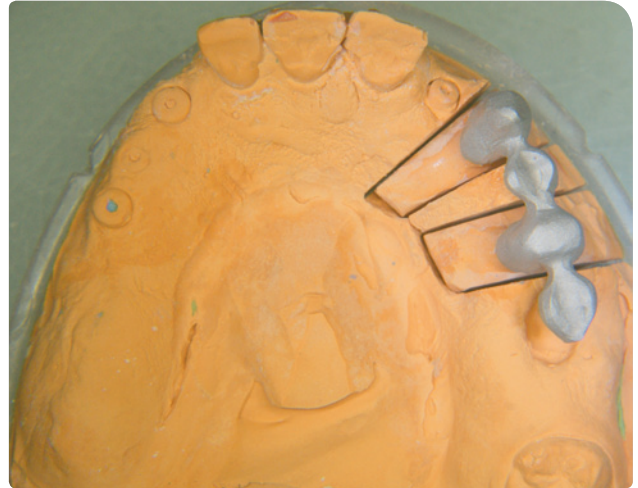
**Fig. 4:**  
Plaster die with framework 23-25-attachment 26

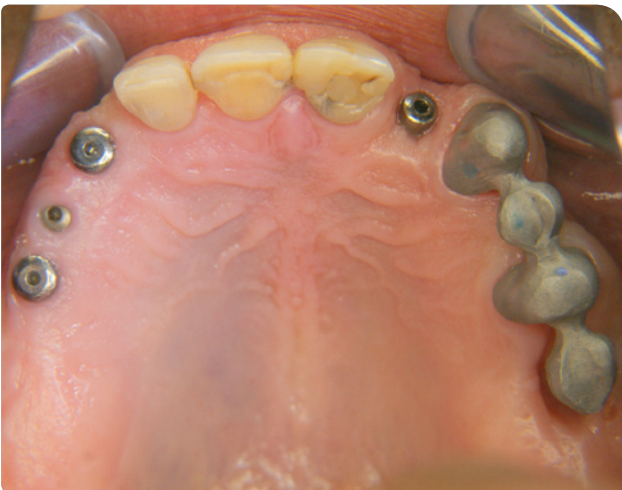
**Fig. 5:**  
Intraoral view with gingiva formers 13, 14, 15, 22 and framework 23-25-attachment 26

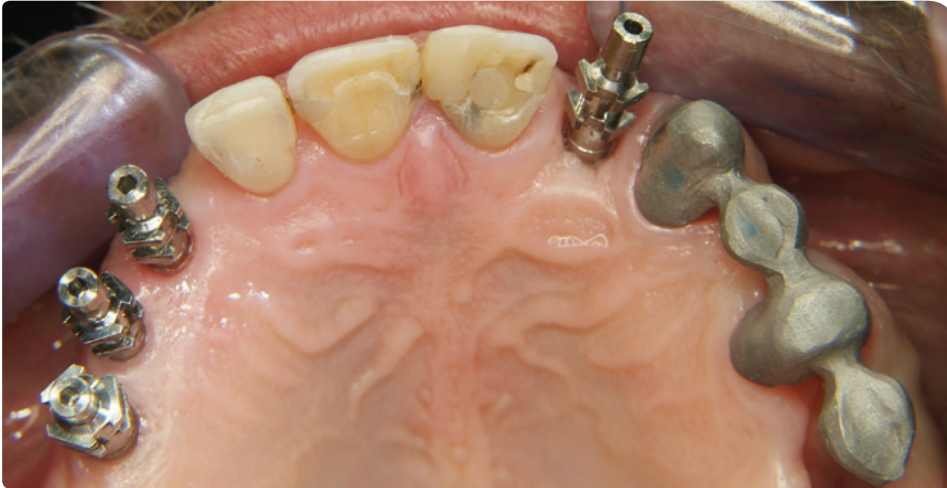
**Fig. 6:**  
IMPLA impression posts 13, 14, 15, 22 and framework 23-25-attachment 26

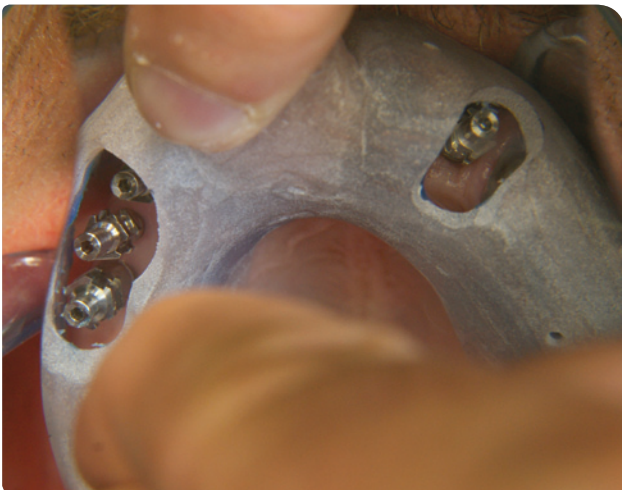
**Fig. 7:**  
Trying in the individual upper jaw tray

After inserting the impression posts 13, 14, 15 and 22, the framework 23-25-attachment 26 was set in and the individual upper jaw tray was tried in (Fig. 7). With the individual tray for the upper jaw and the impression material Impregum F, an impression of both the IMPLA impression posts and the framework was taken at the same time (Fig. 8).

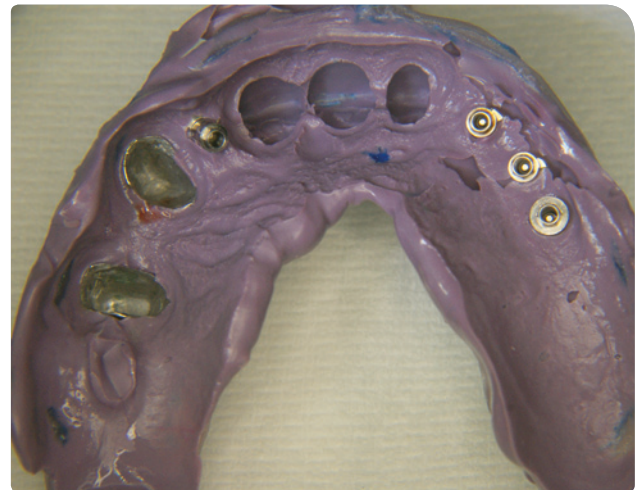
**Fig. 8:**  
Individual upper jaw tray, impression material Impregum F, with impression posts and framework

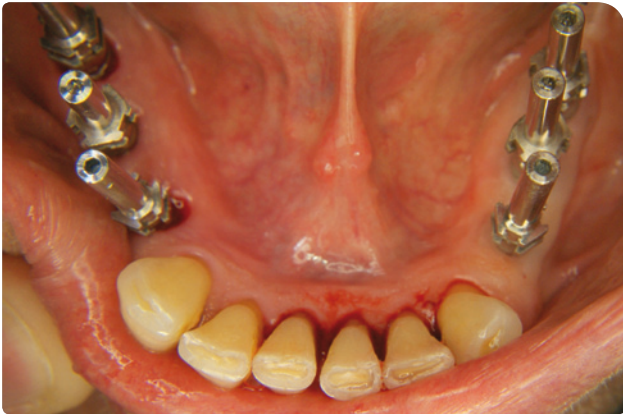
**Fig. 9:**  
Lower jaw with IMPLA impression posts  
(occlusal view)

Subsequently, the impression posts in the lower jaw (Fig. 9 and 10) were inserted and next, the individual lower jaw tray was tried in (Fig. 11). An impression of the impression posts in the lower jaw was taken with the individual lower jaw tray and the impression material Impregum F (Fig. 12). The inner screws of the inserted IMPLA upper jaw implant were covered with Cavit (Fig. 13). Finally, the finished upper jaw restoration was inserted: 13-14-15-attachment 16, individual crown 22, bridge 23-25-attachment 26 (Fig. 14).

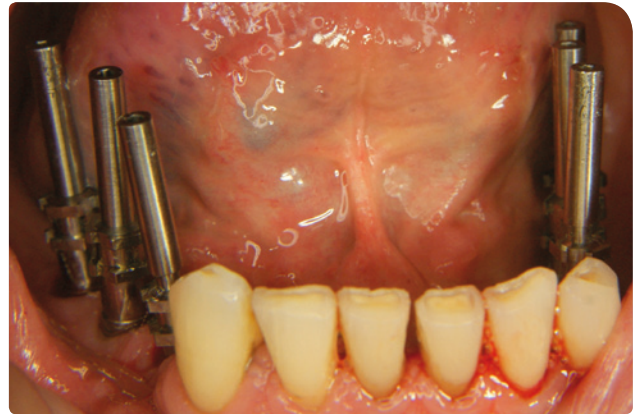
**Fig. 10:**  
Lower jaw with IMPLA impression posts  
(front view)

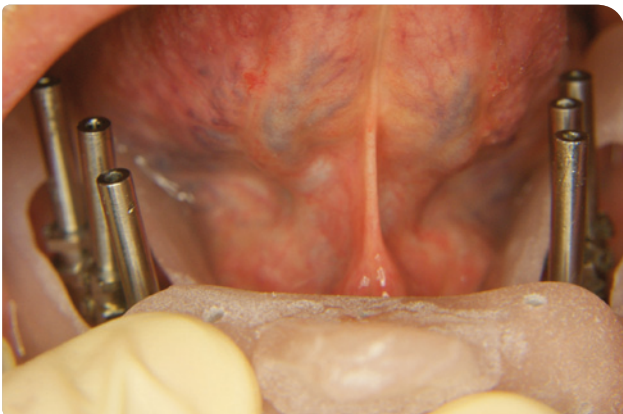
**Fig. 11:**  
Try-in of the individual lower jaw impression  
tray

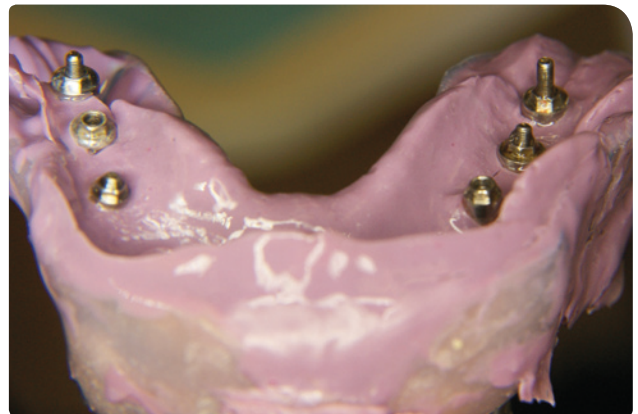
**Fig. 12:**  
Individual lower jaw impression tray,  
impression material with impression posts

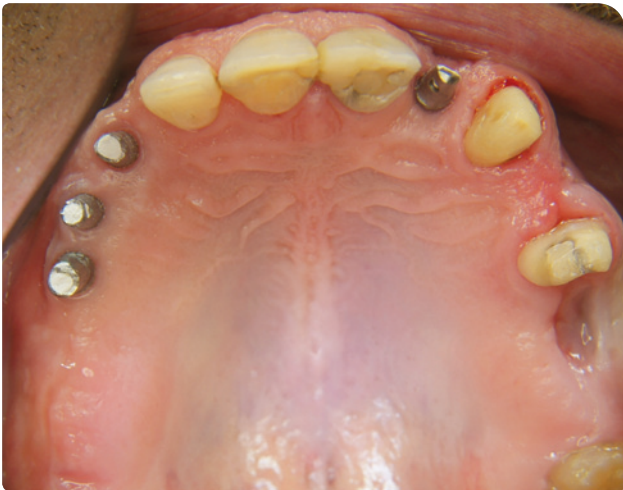
**Fig. 13:**  
Screw-fixed IMPLA upper jaw attachments,  
inner screws covered with Cavit.

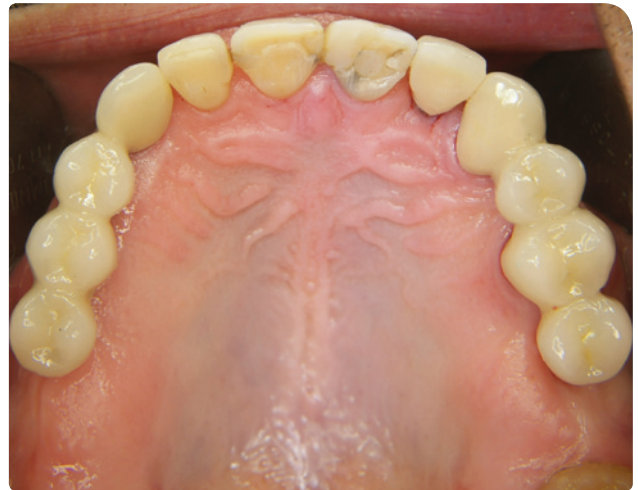
**Fig. 14:**  
Inserted restoration in the upper jaw:  
13-14-15-attachment 16, individual crown 22,  
bridge 23-25-attachment 26, veneered with  
Nuance 850 ceramics (Schütz Dental).

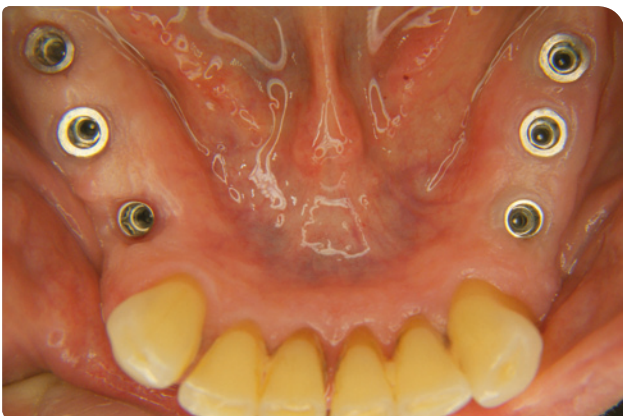
**Fig. 15:**  
Lower jaw: implants after removal of the  
covering screws (view from above)

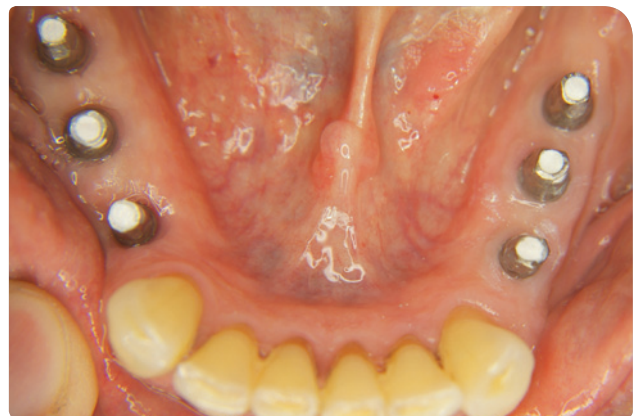
**Fig. 16:**  
IMPLA lower jaw abutments, screwed in,  
inner screws covered with Cavit.

In the lower jaw, the IMPLA lower jaw abutments were screwed in and the inner screws were covered with Cavit (Fig. 16 and Fig 17). The lower jaw restoration was inserted: crowns 34-36 and 44-46 (Fig. 18).

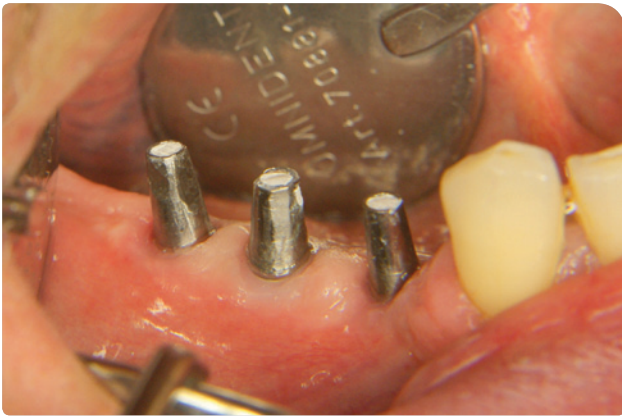
**Fig. 17:**  
Screwed in IMPLA lower jaw abutments,  
inner screws covered with Cavit, lower right,  
buccal view

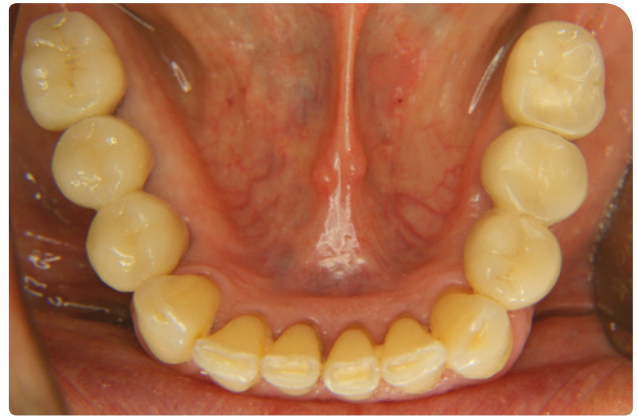
**Fig. 18:**  
Lower jaw restoration inserted: crowns 34-36  
and 44-46, veneered with Nuance 850  
(Schütz Dental)

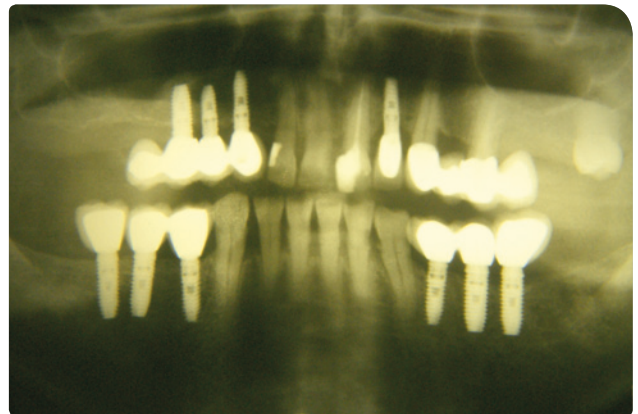
**Fig. 20:**  
OPG (with restoration): after the treatment

Six months after the treatment, the patient is very satisfied with his functional and aesthetic restorations (Fig. 19). The situation was checked via OPG (Fig. 20).
